CAPSULE SUMMARY
BA- 576
John Morrow House
2702 Cotter Road
Millers, Baltimore County
1762
Private

# Maryland Historical Trust Maryland Inventory of Historic Properties Form

1. Name of F	Property	(indicate preferred	name)				
historic	John Morrow Ho	use (preferred), Nicholas	Cotter House				
other							
2. Location							
street and number	2702 Cotter Road	1				_ not for	publication
city, town	Millers					vicinity	
county	Baltimore County	/

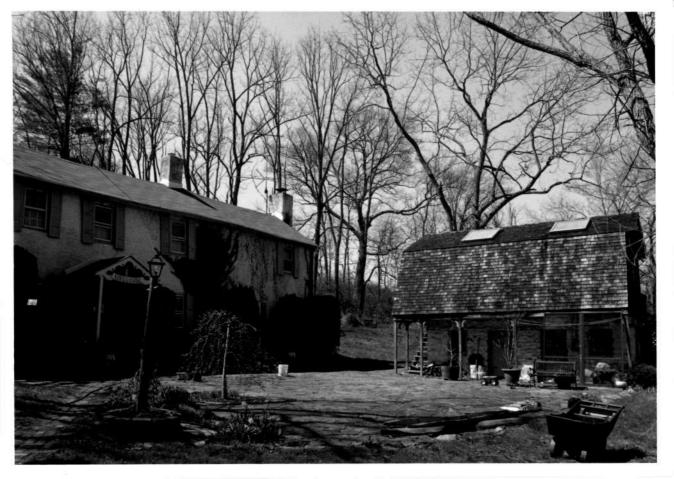
1 of 3

Erected in 1762, this vernacular dwelling, clad with stucco since the 1930s, was originally a two-bays-wide log structure with a three-bay wide addition. Located close to the road, the house fronts east on large, grassy lot with a pond to the north. Currently, it has a continuous side gable roof with asphalt shingles that connects its two sections. Seven 6/6 windows and two single-leaf, wood doors that are paneled with lights pierce the façade. All of the windows have wood sills and surrounds with square edges. A distinguishing feature of the building is the exterior end chimney on the north side of the original section. This shouldered chimney, which has been clad with stucco, centrally occupies half of the north elevation. Other attributes include a stuccoed central interior chimney, a circa 1990 wood portico, and a circa 1960 cinder block addition on the rear with a shed roof. This addition includes a cinder block chimney on the exterior end and a porch that is enclosed with one-light windows.

E ELEVATION

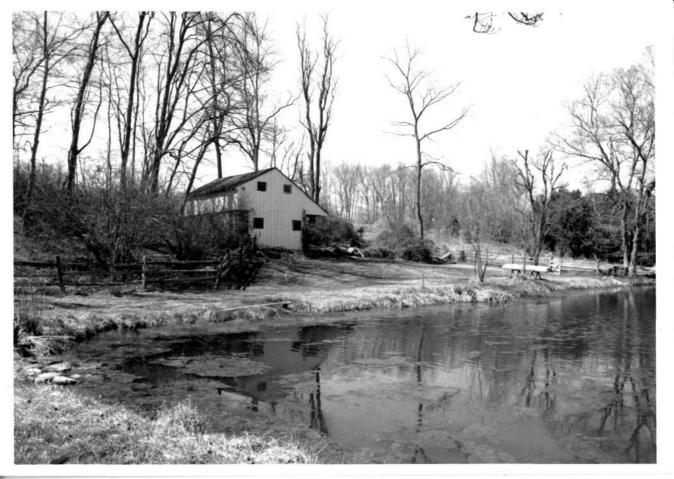
3 2/3

The barn is located west of the pond was built circa 1850. This structure has a random rubble stone foundation and board-and-batten siding. The side gable roof with asphalt shingles overhangs above the four-leaf board-and-batten door.

BARN
